AN INSIDE LOOK AT **CORROSION** IN **COMPOSITE LAMINATES**

Boron-Free E-CR Glass Fibers Demonstrate Superior Corrosion Resistance Compared to E-Glass When Used in Composite Structures Exposed to Sulfuric Acid. Previous Research on Leaching Mechanism of E-Glass in Acids is Confirmed Visually.

By Kevin Spoo, CCT, CCT-C,
6 σ Research Associate,
OCV™ Reinforcements,
and Marie Kalinowski,
Senior Scientist,
Owens Corning Analytical
Testing and Terry Gano,
Research Technician

April 2010

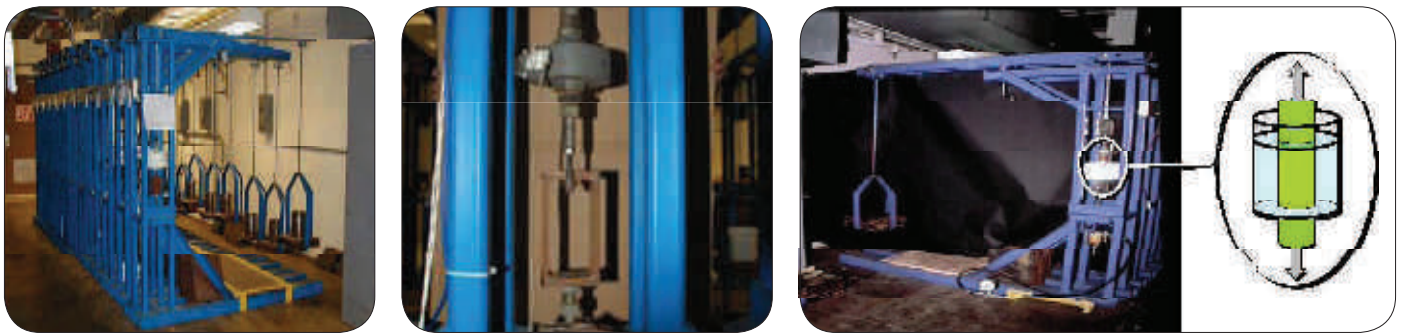
When the rod was removed, it was cut into 2" long pieces and immersed in a 10% sulfuric acid solution. It remained in this solution at 25°C for several months. Rod pieces were removed periodically and examined by the Owens Corning Microscopy Lab. Unlike the photo on the far right shown below, these rods were not exposed to corrosive fluid under stress as is typical in stress-corrosion testing.

The preparation procedure used in the Microscopy Lab was to pot the sample in epoxy resin and remove about 1 mm of material from the rod end through polishing of the sample. SEM photos were taken of the rod cross-sections at various levels of magnification. Additionally, when corrosion of fibers was seen, EDX spectrographs were made to determine if corrosion was actually taking place by monitoring compositional changes in areas of the glass fiber.

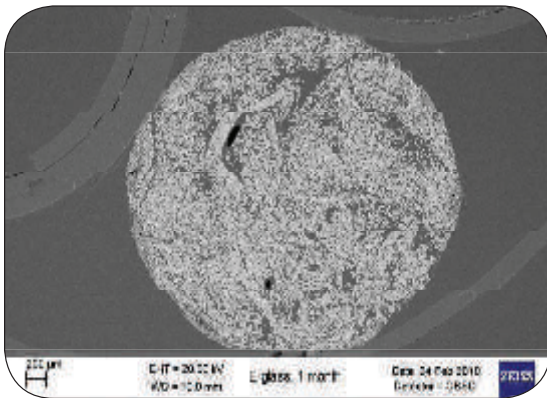
1. E-glass rod, one month in 10% H₂SO₄

Photos 1 and 2 show low magnification views of the E-glass and Advantex® glass samples after one month exposure to 10% sulfuric acid. The photos serve as a reference of the corrosion resistance of each glass type before examining selected areas of the rods. They also serve as a reference when comparing the differences between one-month exposure and three-month exposure.

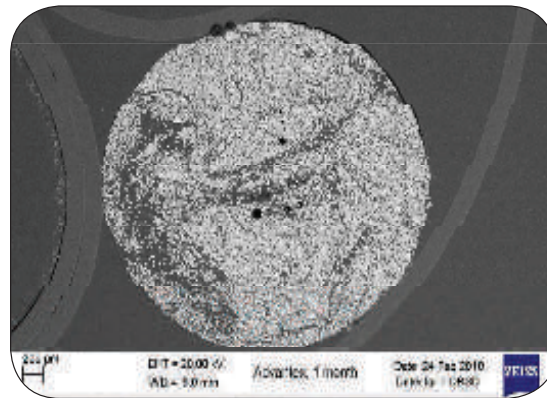
2. Advantex® glass rod, one month in 10% H₂SO₄

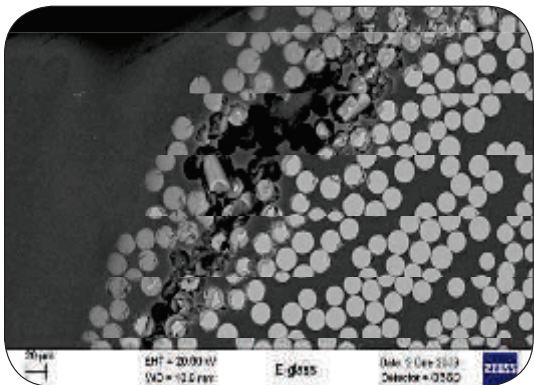
3. E-glass rod, one month in 10% H₂SO₄

When looking at the 1/8" E-glass rod in cross-section (photo 3), what we see is white fibers near the center of the rod, gray fibers at the exterior of the rod and voids apparent along the crack. The gray fibers have had components of the glass leached from the fiber. This proceeds from the outside of the rod inward and from the outside of the individual filaments inward.

A de-bonding of a number of fibers from the resin matrix has also occurred. The task of polishing the surface to obtain these photomicrographs could be suspected of creating these cracks, but normally if that had occurred cracks would be dispersed throughout the circumference of the part, and they are not. The rods were under no stress during chemical exposure, so a likely cause could be latent resin shrinkage as the resin de-bonds from the fiber and the fiber disappears.

This resin, like most unsaturated polyesters, has an 8% volumetric shrinkage and latent built-up stress is possible. The task of polishing accounts for some of the fibers being pulled out of what is now a void area. The empty holes where fibers were previously, appears black (void).

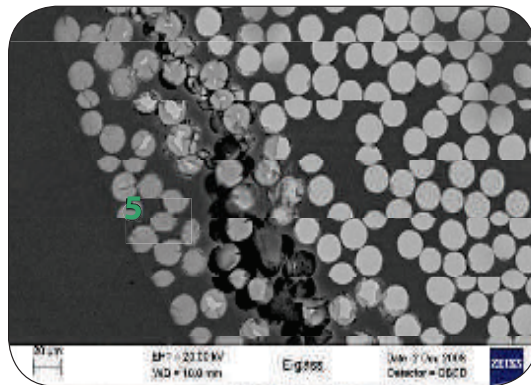
4. E-glass rod, one month in 10% H₂SO₄

Confirmation of leaching was obtained by running EDX spectrometry on fibers in photos 4 and 5 with the locations of each sampling appearing with green numbers on the sampling locations. EDX is a fast and convenient tool for measuring the composition of glass fibers but it does have some drawbacks. It cannot measure elements of atomic weight lower than carbon (C), and this includes boron (B). Boron is a key element in E-glass and previous studies have shown it is attacked readily by acids.

The sampling locations in photos 4 and 5, and subsequent photos (green numbers), are referenced on the top of Table 1. The composition of this E-glass fiber is known and is shown in column zero in the table below.

An EDX analysis of the fiber that has not yet been corroded is shown in columns 1 and 3 while columns 2, 4, and 5 (highlighted in gray) show the analysis of fibers that have gray patches (shown in the photos) indicating corrosion. The EDX analysis of columns 1 and 3 compared to that of column zero shows the shift in percentages of various oxides of each element of the glass fiber that occurs as a result of the limitations of the EDX.

Despite the limitations of EDX, it can be seen that the difference between non-corroded fibers 1 and 3 and corroded fibers 2, 4, and 5 are huge (see green numbering of fibers in photos 4 and 5 on page 5). The increase in silica content in 2, 4, and 5 and the disappearance of boron (earlier work) and reduction in alumina and calcium are indications that most of the glass components (except silica) are being leached from the fibers. This is after a relatively short period of exposure to 10% sulfuric acid under no stress.

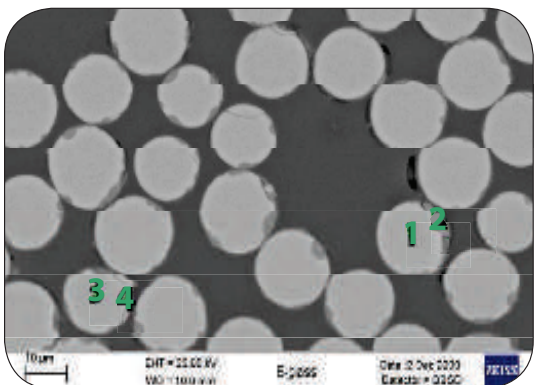
5. E-glass rod, one month in 10% H₂SO₄

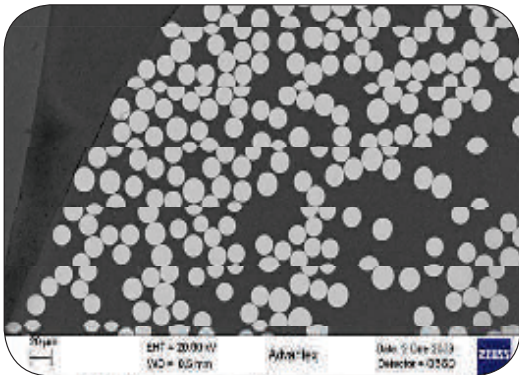
6. Advantex® glass rod, one month 10% H₂SO₄

Conversely, photos 6 and 7 show no gray (corroded) sections of fibers and Table 1 shows little if any change in the Advantex® glass composition, regardless of the sampling location. Since Advantex® glass does not contain boron, EDX provides a true analysis of the glass composition.

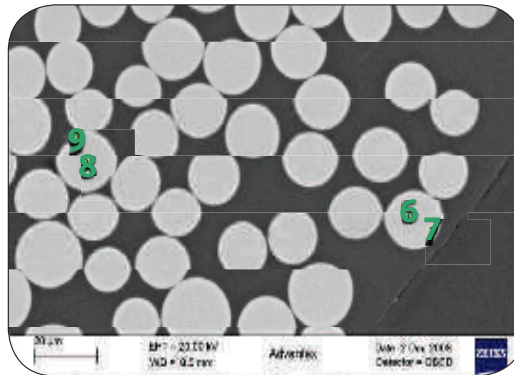
7. Advantex® glass rod, one month 10% H₂SO₄

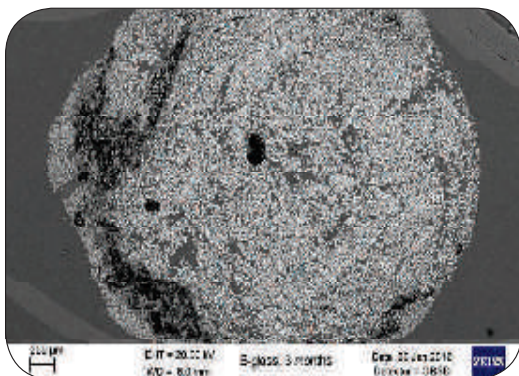
8. E-glass rod, three months 10% H₂SO₄

While the resistance to corrosion of the Advantex® glass compared to E-glass at one month is dramatic, it was decided to continue the work to see if any new information could be gleaned from longer exposure times. Photos 8 through 13 show E-glass and Advantex® glass composite rods after three-month exposure in 10% sulfuric acid.

The E-glass sample shows gray fibers along the entire perimeter of the rod and considerable damage on the left-hand side of the photo. Deformation of the rod has occurred as the E-glass deteriorates. Photos 10 and 11 show a higher magnification of this area and the de-bonding and subsequent fracturing that occurs. Little if any deterioration of the resin has occurred although some resin and glass shards likely have been washed away in the polishing and washing of the sample during preparation.

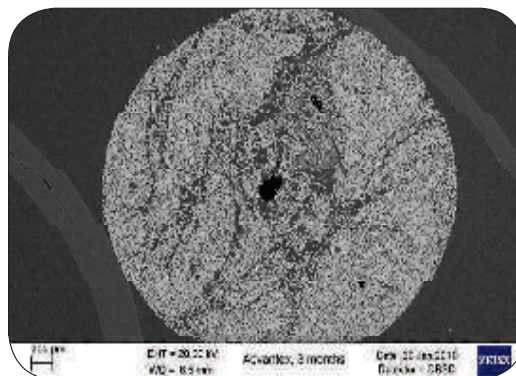
9. Advantex® rod, three months 10% H₂SO₄

Another seemingly puzzling feature of both E-glass and Advantex® glass photos are the large patches of gray. Corroded fibers are not unusual for E-glass rods but were unexpected for Advantex® rods. Photo 9 shows a hint of the problem, but curiously, all the fibers look non-corroded. A closer examination (see photos 14 and 15) of the Advantex® glass-reinforced rod shows that these are not corroded fibers. Instead, a crystalline deposit has formed on the cross-section of the rods scattering the light to make the surface look gray under low magnification.

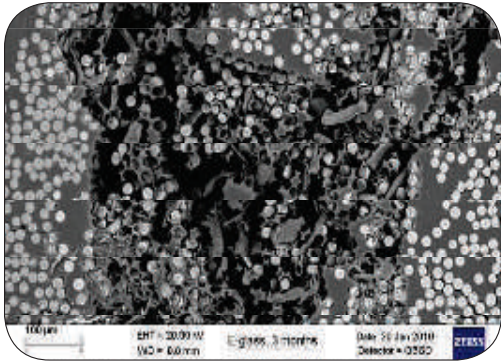
10. E-glass rod, three months 10% H₂SO₄

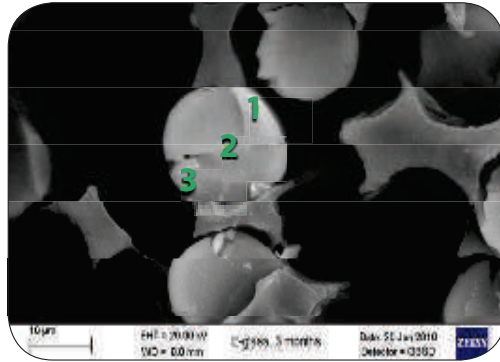
11. E-glass rod, three months 10% H₂SO₄

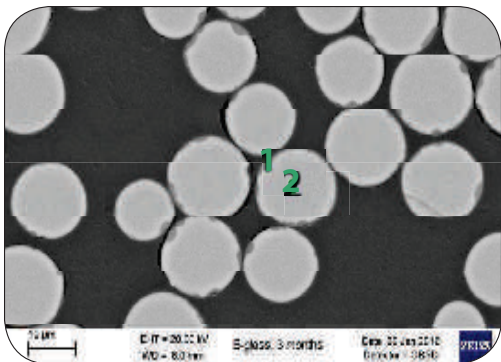
12. E-glass rod, three months 10% H₂SO₄

Photos 12 and 13 show EDX samples of selected areas along the corroded rods. The results are displayed in Table 2. The results for the E-glass sample were not unexpected and are similar to previous EDX sampling at one month. However, the gray area in photo 13 was completely unexpected because Advantex® glass was not expected to corrode. EDX analysis showed that the composition of sections 3 and 4 were nearly identical and showed no corrosion. Closer examination of the gray area in photo 13 showed it to be a chip on the filament which scatters light differently.

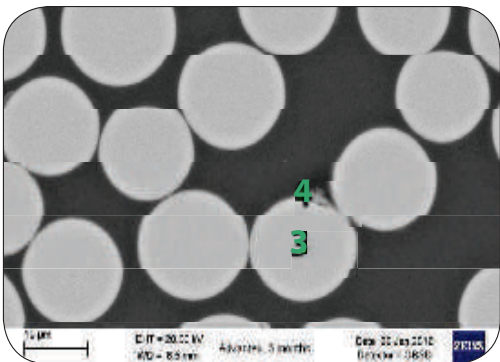
13. Advantex® rod, three months 10% H₂SO₄

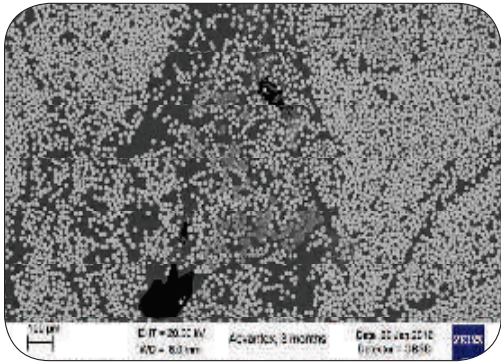
14. Advantex® glass rod, three months 10% H₂SO₄

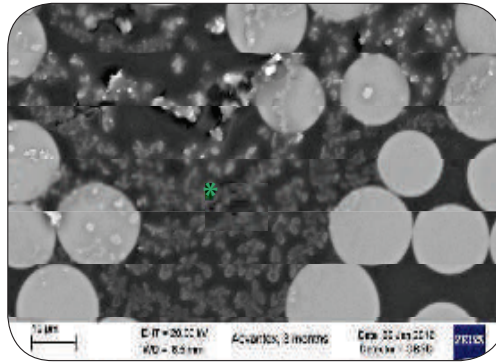
15. Advantex® glass rod, three months 10% H₂SO₄

An EDX analysis of the sample area in photo 15 (green star) is shown in Table 2. The analysis shows C (carbon), O (oxygen) and S (sulfur). Although there is enough oxygen to suggest this could be a mixture of carbonates and sulfates, it seems odd the carbonates could exist in this previously acidic environment.

No conclusion as to the nature of these crystals has been made. No cations were found in the vicinity of the crystals which might have indicated a leaching of components from the glass. A survey of both the E-glass and Advantex® rods show that these crystals appear more prevalent in the vicinity of cracks and voids. Additionally, it should be remembered that EDX cannot detect atomic numbers lower than Carbon. The only likely candidates having atomic numbers lower than carbon are boron and hydrogen. However, Advantex® does not contain boron.

Since the preparation of a sample for SEM requires putting the samples under very low pressure (vacuum) for an extended period of time, it is suspected that these might be sulfuric acid crystals. But then a higher level of sulfur in the analysis would be suspected. Sulfur is present and it begs the question of how the acid (or sulfate compound) could have migrated through a seemingly intact rod. Either diffusion is occurring through the resin matrix or cracks formed in the resin matrix as a result of previously straining the rods prior to immersion. In any event, this mystery appears to be a fertile area for investigation.

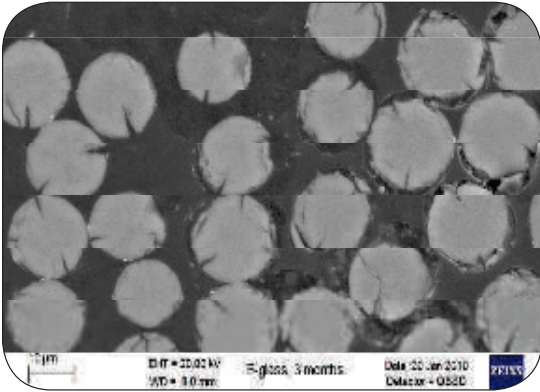
16. E-glass rod, three months 10% H₂SO₄

Lastly, another series of interesting pictures confirms observations seen earlier and presented in the literature³. Both photos 16 and 17 are of E-glass fibers. Photo 16 was taken in the same series of pictures as photos 1 through 15 and is a very high magnification of E-glass fiber composites rods exposed to 10% sulfuric acid for three months. The end view of these fibers shows cracks very similar to helical cracks that typically form on E-glass exposed to corrosive environments. Photo 17, taken several years earlier of the exact same package of E-glass, shows a single filament of E-glass exposed to 5% hydrochloric acid for two hours at 96°C under no load.

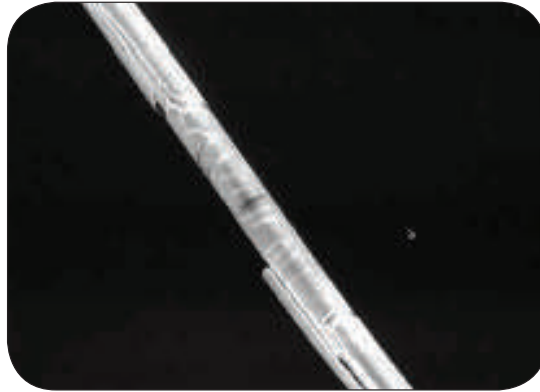
17. E-glass fiber 2 hrs @96C in 5% HCl
